# MOORE

HOME • INSPECTION • SERVICES

RE: 1234 Really Nice Court Inspection Report

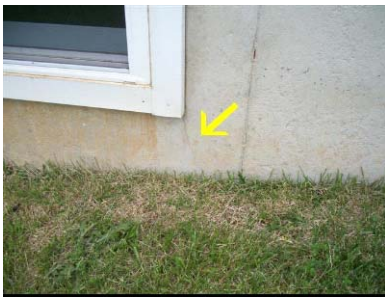
Appeared serviceable, except: Cracks noted at rear were typical/minor. Monitor over time. An original construction error was noted at the north wall where it appeared that a basement window opening was provided and then sealed up with concrete. This window opening roughly corresponds to the area of the basement stairwell. This condition did not appear to be structurally significant. Monitor over time.

Crack at rear

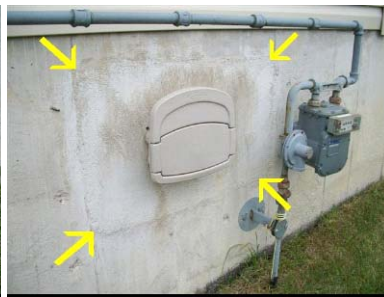
Construction error

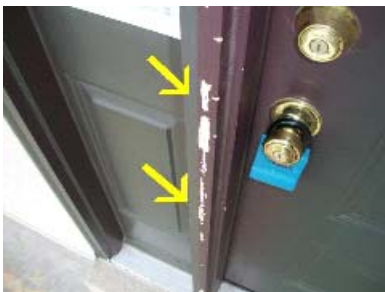
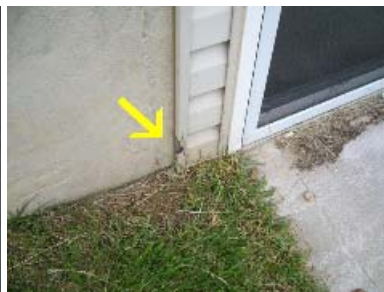
Appeared serviceable, except: Paint/finish needed at some wood trim. Some trim areas may need better caulking or sealing to ensure a tight seal. Damage to some vinyl trim was noted at the rear walkout doorway.

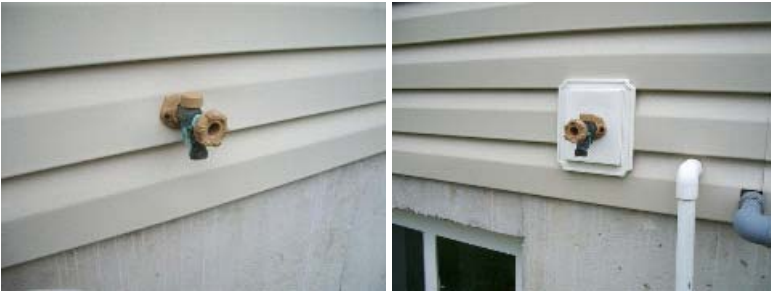
Appeared serviceable, except: Multiple inoperative faucets were noted. NOTE: This could be due to disconnected pipes or a closed valve inside the house. Such valves are not opened or operated during our inspection due to the possibility of failure or leakage.

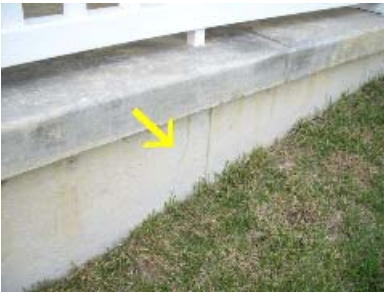
Appeared serviceable, except: Cracks noted were typical/minor.

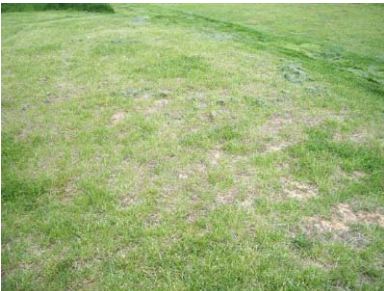
Lawns

Appeared maintained, except: Some minor to moderate maintenance will be needed to lawns. The trimming back of overgrowth is recommended at some exterior walls and windows.

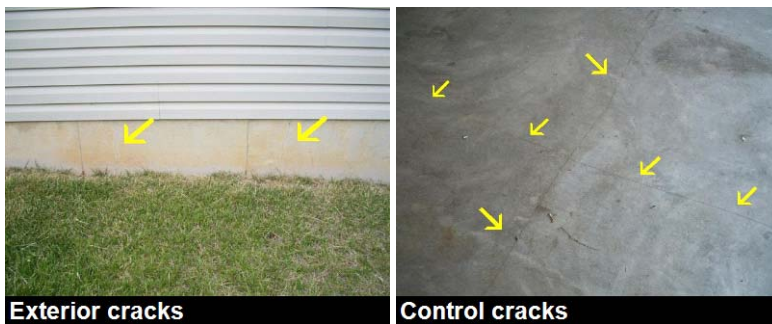
Appeared serviceable, except: Cracks noted at exterior foundation were typical/minor. NOTE: The cracks noted on the interior floor slab are control cracks and typically occur as part of the floors original design and construction.

Exterior cracks

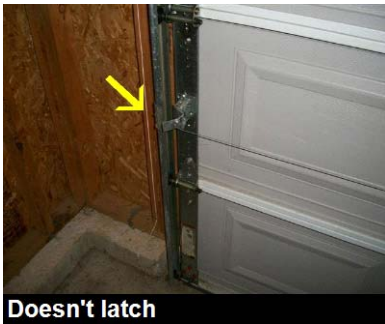
Garage door was manual with no opener. The door appeared serviceable, except: The door does not currently lock and garage security is currently lacking. The side latches have been permanently left in the open position which is consistent with previous electric opener usage. Additional means of securing the door are recommended.

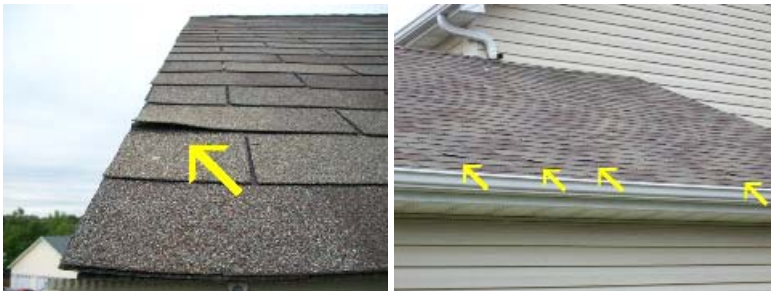
Appeared serviceable/within useful life, except the following. Nails/fasteners were popping up and visible below some roof shingles. The removal of popped nails and the sealing of the hole with caulk or cement is recommended.

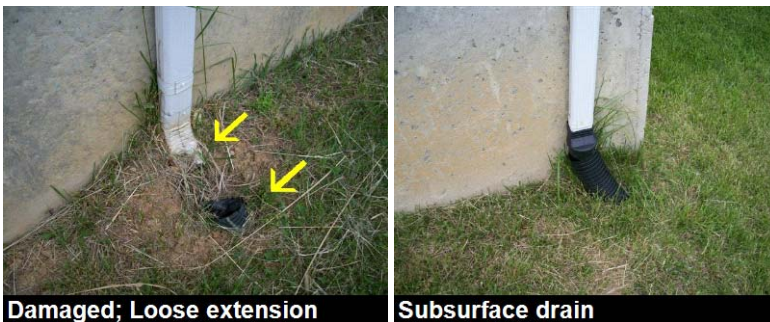
NOTES: Gutters and downspouts play an important role in diverting water away from the foundation wall. Their proper installation and maintenance should not be overlooked. Subsurface drains were noted at some downspouts. The subsurface portions of these downspouts were not inspected. We recommend you monitor the performance of any subsurface drain line during times of heavy rain and make corrections as needed.

Damaged; Loose extension

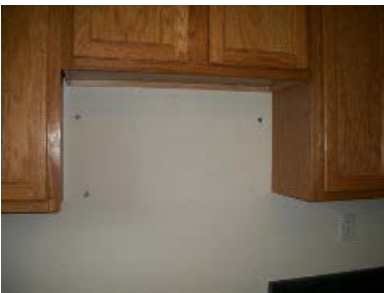
No fan/hood was viewed. Ventilation appeared to be lacking in the kitchen area. We recommend the installation of a proper fan/hood unit or built-in microwave which incorporates a fan/hood. We recommend further evaluation and necessary repairs by a qualified professional familiar with such conditions.

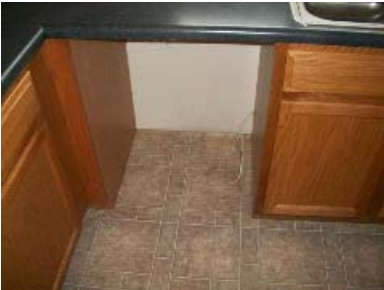
No unit was viewed. Electrical and plumbing hookups were noted and appeared serviceable. A complete dishwasher installation will be needed. We recommend further evaluation and necessary repairs by a qualified professional familiar with such conditions.

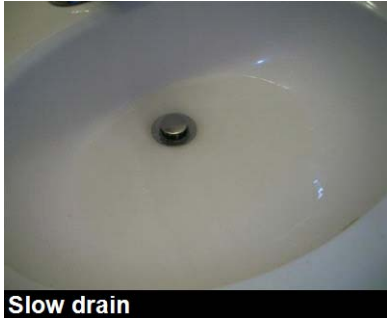
The sink surfaces, hardware and plumbing all appeared serviceable, except: Corrosion was noted at some pipes or hardware. Drainage was a bit slower than normal.

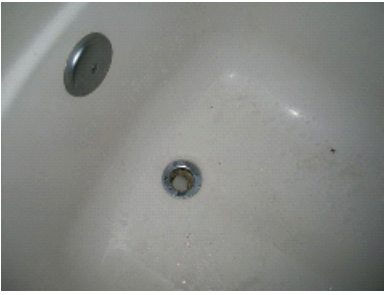
All tub/shower fixtures appeared serviceable, except: Stopper was missing. No manual stopper was viewed.

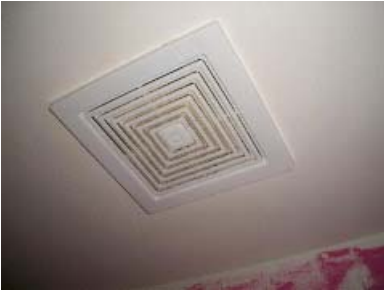
Appeared serviceable, except: Exhaust fan appeared dirty. NOTE: See ATTIC ACCESSIBILITY AND CONDITION for further details on this fan unit's ductwork.

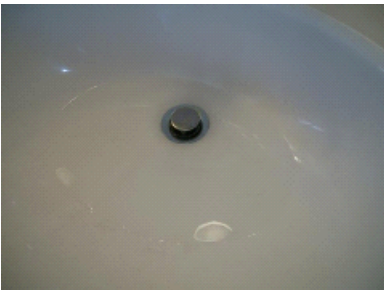
Adequate water pressure was noted. The sink surfaces, hardware and plumbing all appeared serviceable, except: Drainage at one sink was a bit slower than normal.

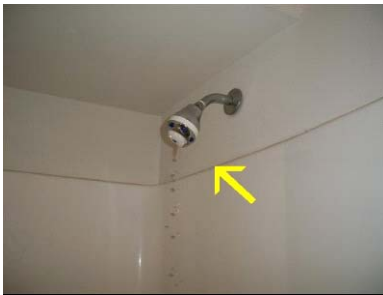
All tub/shower fixtures appeared serviceable, except: Moderate to major leakage or dripping was noted at the shower head. Repairs will be needed. Poor seals at the shower doors were also noted. New caulking is needed in both the tub and shower areas. We recommend further evaluation and necessary repairs by a qualified professional familiar with such conditions.

Leakage at shower

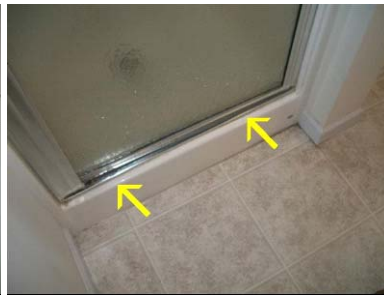
Poor seals

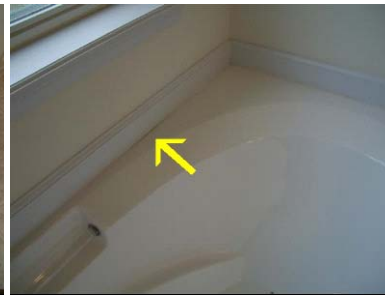
Caulking recommended

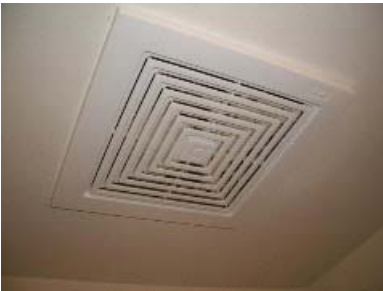
Appeared marginal to unsatisfactory. Exhaust fan did not operate. The exact cause of the problem was not determined. Repair or replacement will be needed. We recommend further evaluation and necessary repairs by a qualified professional familiar with such conditions.

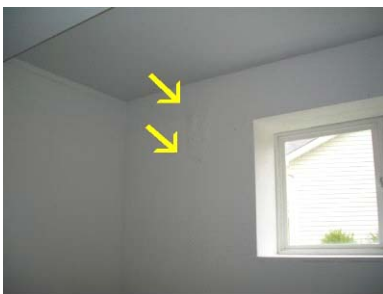
The interior structure is predominantly wood frame construction. Drywall or gypsum board is the primary wall material. Interior walls as a whole appeared serviceable with minor wear, cracking or damage noted. Some basement wall surfaces were incomplete. Water damage was observed in the finished basement room near the side window. The status or origin of the water damage was not fully determined. The damage may be from an active problem or may be evidence of a past problem which has since been corrected. The area of water damage roughly corresponds to the exterior water faucet line which was shut off at the time of the inspection. A leak may be present at this water line (between the shut off valve and the exterior faucet). We recommend further evaluation and necessary repairs by a qualified professional familiar with such conditions.

Moisture damage

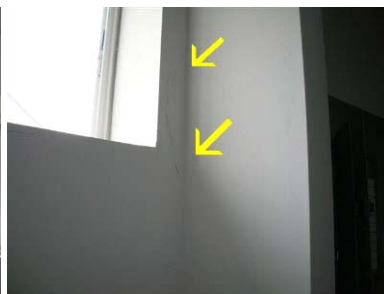
Moisture damage

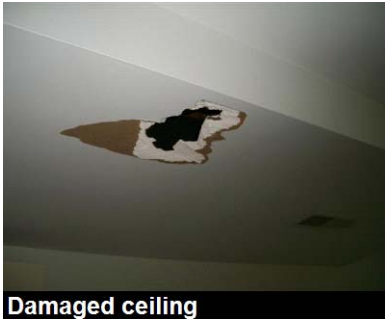
Drywall or gypsum board is the primary ceiling material. Interior ceilings as a whole appeared serviceable, except: Damage/deterioration was noted in the basement at the finished room ceiling. This appeared to be an attempt to gain access to the exterior water faucet's interior shut off valve. Although not definitively determined, this need for access to the water shut off valve may be related to the water damage seen at the adjacent wall. See INTERIOR WALLS for details. Drywall fasteners were popping through or exposed at some second floor locations. This is minor or typical. Make repairs as needed.

**Damaged ceiling**

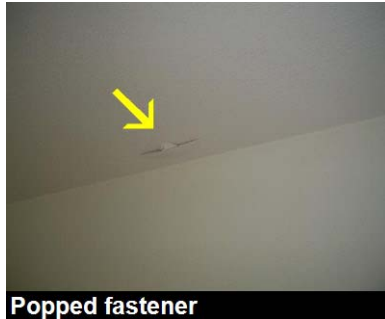
**Popped fastener**

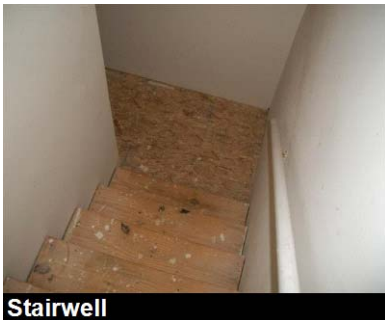
**Stairwell**

A combination of types were noted throughout. Carpet. Vinyl. Hard wood. Flooring as a whole appeared serviceable, except: The basement stairwell surfaces were missing finished flooring. Only the sub floor or underlayment was present at the time of inspection. Some basement carpeting was loose or buckled.

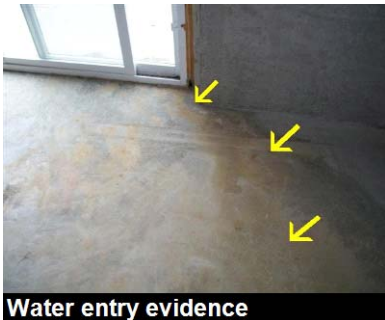
Doors are a mix of standard hinged single doors and sliding doors. The exterior doors and storm doors as a whole appeared serviceable, except: Paint/finish needed at some front wood trim. Evidence of moisture penetration was noted at the base of the basement sliding door. Sealing or caulking is recommended at this doorway. Make repairs or improvements as needed.

**Water entry evidence**

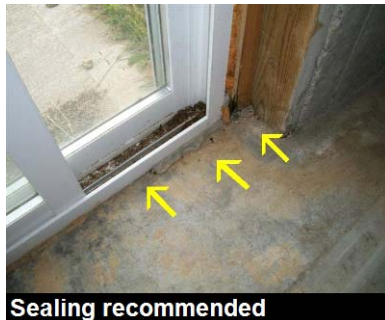
**Sealing recommended**

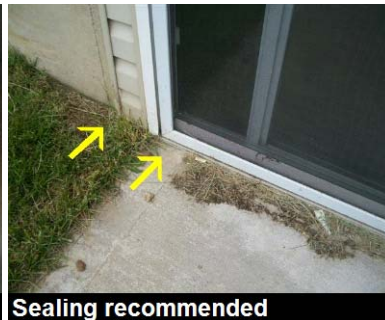
**Sealing recommended**

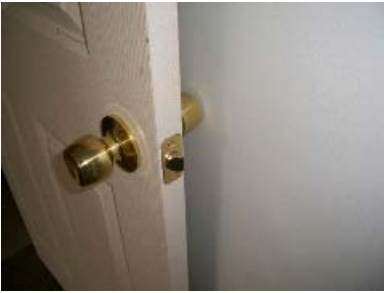
As a whole, the interior room and closet doors appeared serviceable, except: One basement door was missing a door stop device.

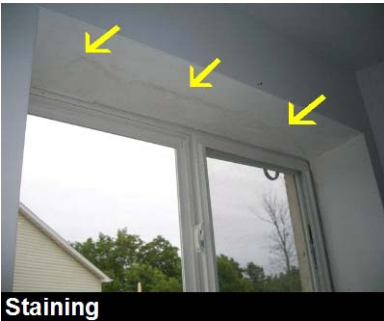
Windows as a whole appeared serviceable, except: Some evidence of moisture penetration was noted around one basement window in the finished room. This appeared to be related to other water entry and damage to the adjacent walls. See INTERIOR WALLS for details. Damage to glass was noted at one master bedroom window. Make repairs or improvements as needed. Some windows were out of reach and were not closely inspected.

**Staining**

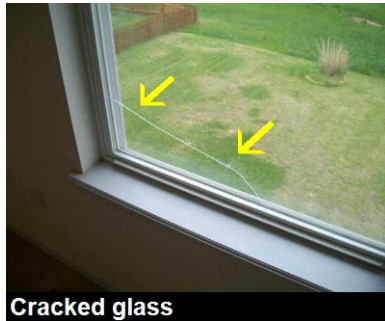
**Cracked glass**

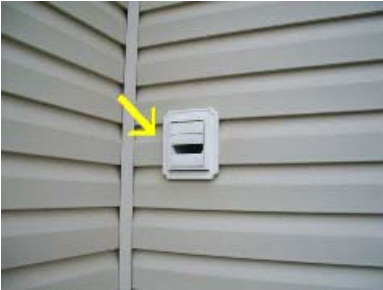
The laundry venting components appeared serviceable, except: The external vent cover was damaged. Repair as needed.

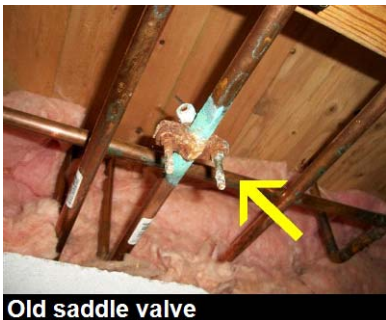
Appeared serviceable, except: 1) Minor corrosion was noted at some valves or fittings. No leakage was noted, but monitor in the future. 2) A potential leakage concern was noted at the north side exterior faucet supply line. See INTERIOR WALLS for further details. NOTE: The supply lines were not completely viewable at the time of the inspection. A limited inspection was performed.

Old saddle valve

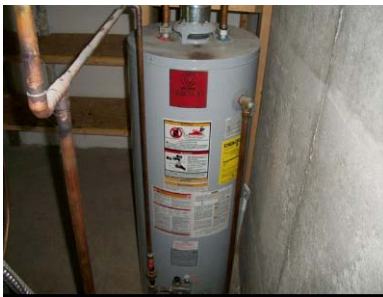
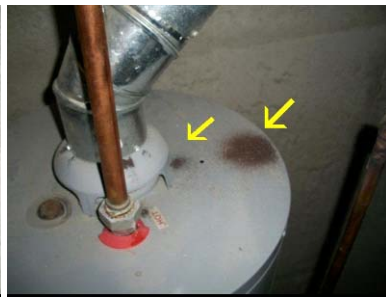
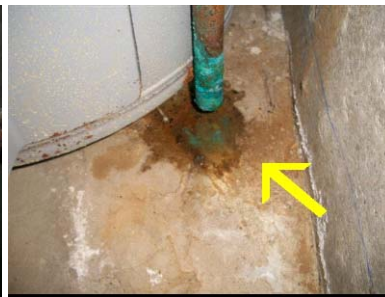
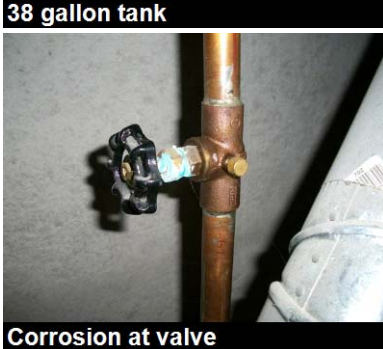
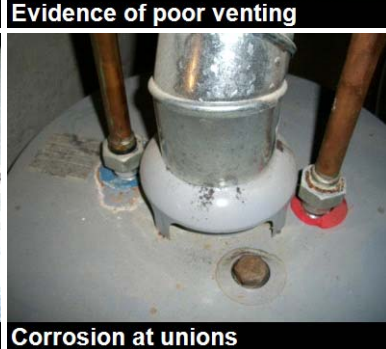
Flue vent was intact with proper rise. A water shutoff valve was viewed. A gas shutoff valve was viewed. Unit appeared serviceable, except: 1) This 38 gallon tank may not be adequately sized for this house. Consider upgrading to a 50 gallon tank. 2) Evidence of poor venting performance and possible backventing was viewed at or near the draft hood or vent connector. Further testing is recommended. 3) The unit's temperature pressure relief (TPR) valve appeared to be leaking. Leakage was viewed at the end of the TPR discharge tube. This valve may need to be replaced. 4) Minor to moderate corrosion was noted on the water shut off valve and pipe unions. We recommend further evaluation and necessary repairs by a qualified professional familiar with such conditions.

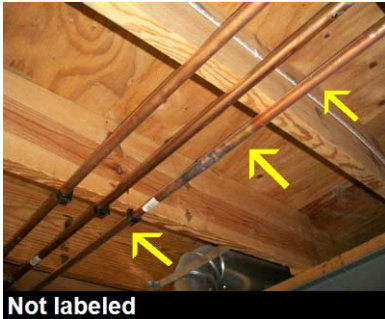
System appeared serviceable, except: Portions of the 1/2" or 3/4" copper natural gas lines did not appear to be properly labeled to distinguish them from similar water supply lines. This is a potential safety hazard should the gas lines be mistaken for water supply lines. We recommend properly labeling all 1/2" and 3/4" copper gas lines.

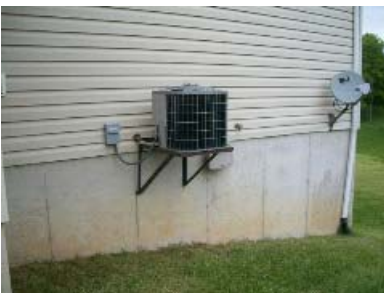
Appeared serviceable, except: Unit produced only a low to moderate air temperature drop. A temperature drop of 18-22 degrees is considered excellent. We recommend servicing the system and checking the refrigerant levels. We recommend further evaluation and necessary repairs by a qualified professional familiar with such conditions.

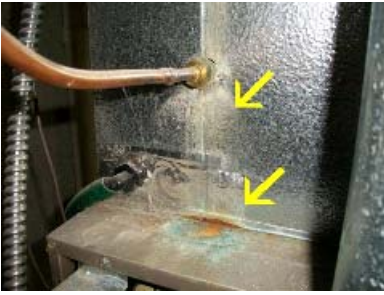
A condensate line was installed. However, the flow of condensation could not be tested during our inspection. The condensate line appeared serviceable, except: Evidence was viewed which suggests that condensation water from the air conditioner's A-coil has leaked onto the furnace cabinet. The condensate tray and/or line may be broken, clogged or damaged. The condensate water drainage should be monitored during times of air conditioning use for any signs of leakage.

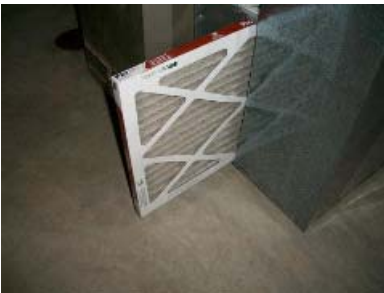
**10.23 AIR FILTERS:**  
Appeared serviceable, except: Filter was dirty. We suggest cleaning or replacing. Filters should be monitored and changed year round as needed to maximize the efficiency of the furnace and air conditioner and also realize the rated life expectancy.

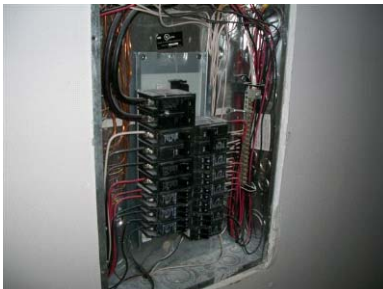
Circuit and wire sizing correct so far as visible. The panel appeared serviceable, except: 1) Although an exterior driven ground was viewed, the primary interior cold water grounding system appeared to be deficient. The cold water ground wire was present and properly attached to some interior copper water pipes (near the main interior valve). However, the plumbing main line at the front foundation wall was non-metallic (plastic) which will not permit electrical ground continuity beyond the plastic/copper connection. In this situation, replacing the plastic main water line with a conductive metal may be cost prohibitive. As such, we recommend checking with the local jurisdiction having authority to determine if the single exterior driven ground is sufficient to meet local codes or occupancy requirements. 2) Some of the branch wire openings were missing appropriate strain relief connectors or clamps. This was seen at the top of the main panel. We recommend further evaluation and necessary repairs by a qualified professional familiar with such conditions.

Nullified interior ground

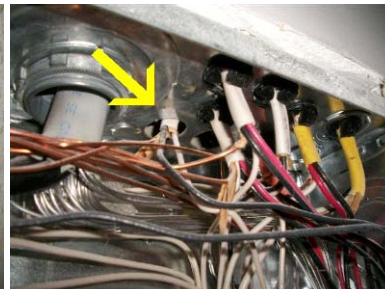
Missing strain relief clamps

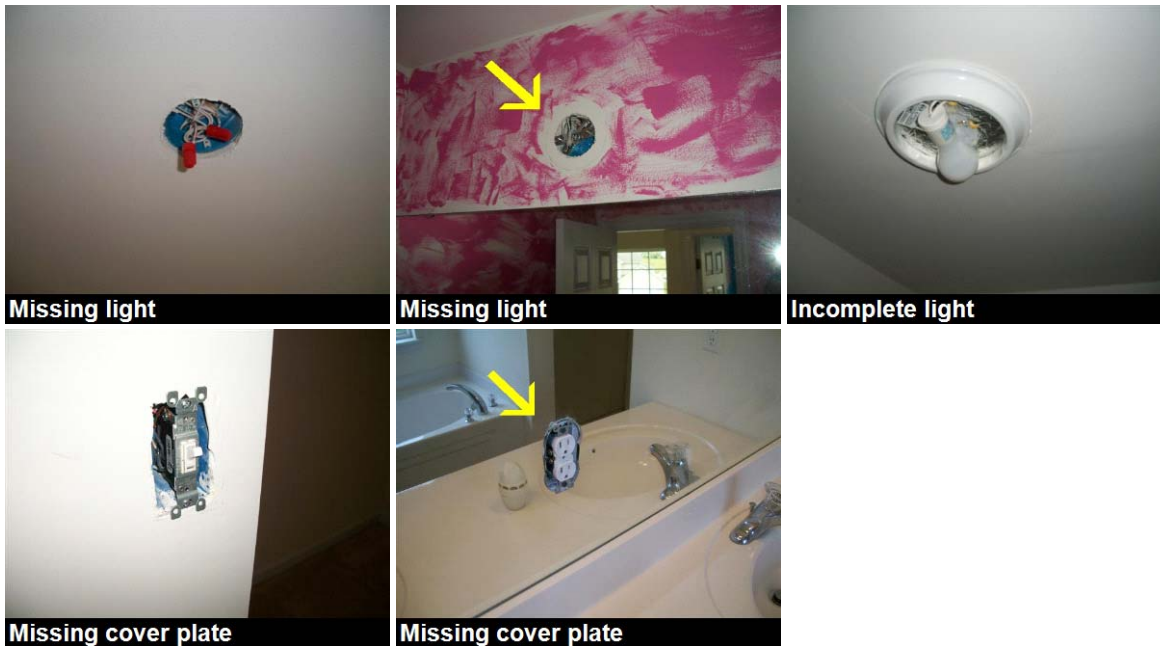
A representative sample of switches, fixtures and outlets was tested. As a whole, switches, fixtures and outlets were in serviceable condition, except: 1) Multiple light fixtures or receptacles were missing or incomplete and had open and potentially live wires remaining at walls or ceilings. This is a safety hazard. Replacement of these devices will be needed. 2) Missing or damaged switch or outlet cover plates were viewed. Installation of cover plates is recommended. 3) Some damaged exterior light fixtures were viewed. 4) Ground Fault Circuit Interrupter (GFCI) outlets were not installed in the garage and laundry areas. GFCI outlets are recommended for installation at exterior, garage, laundry, pool, bathroom & kitchen outlets. Ground fault circuit interrupter (GFCI) outlets provide safety and protection in wet areas. Upgrades are recommended if not present in wet areas. We recommend further evaluation and necessary repairs by a qualified professional familiar with such conditions.

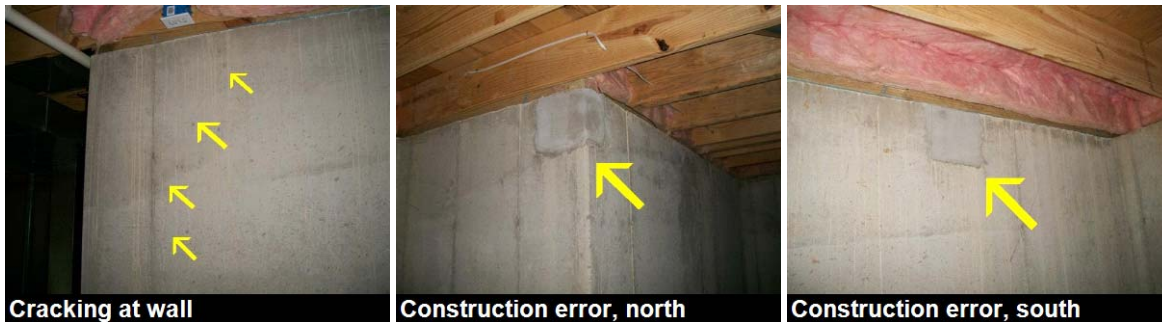
Viewing was restricted. Walls were not fully inspected. Appeared serviceable, except: 1) Minor settlement cracks were noted at the front corner area, above the basement bathroom "rough in" area. This cracking did not appear to be structurally significant. Monitor over time. 2) Original construction errors were also noted at the south and north sides of the front basement area, near the main water valve. It appeared that the concrete walls were notched to accept a steel beam which was not designed to be located in that spot. These patched beam "pockets" did not appear to be structurally significant. Monitor over time.

Cracking at wall

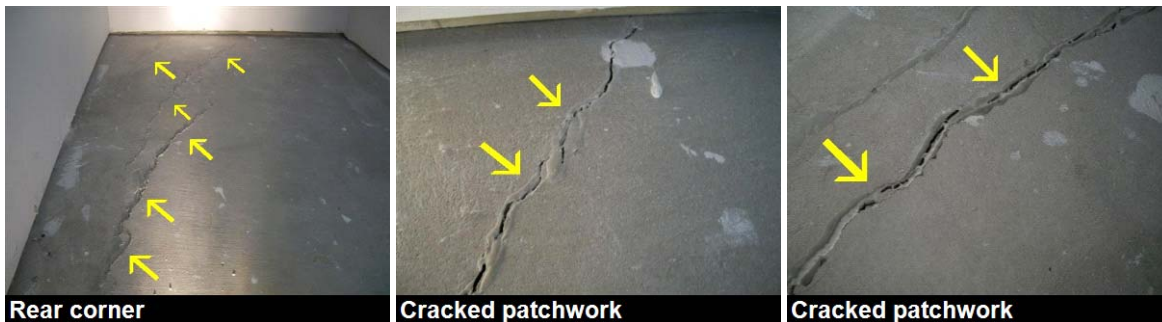
Rear corner

Floor was not fully visible due to coverings or stored items. Appeared serviceable, except: 1) Symptoms of prior water entry exist by the rear door. Water seepage may recur in the future. See EXTERIOR DOORS for further details. 2) Cracks noted at rear north corner were minor to moderate and showed signs of potential active movement or settlement. The cracks appeared to be previously patched and some of the patchwork is splitting or separating. The viewing of the adjacent walls and remaining basement floor was limited by finished surfaces and a full inspection of the settlement problem could not be performed. At a minimum, these cracks should be patched and monitored over time for any signs of further movement or displacement. However, we recommend getting further evaluation of the cracking by a qualified professional familiar with such conditions. NOTE: Structural engineering services were not performed during our inspection. If the structural situations outlined in this report are a major concern for you, the next step would be to employ a structural engineer for further evaluation.

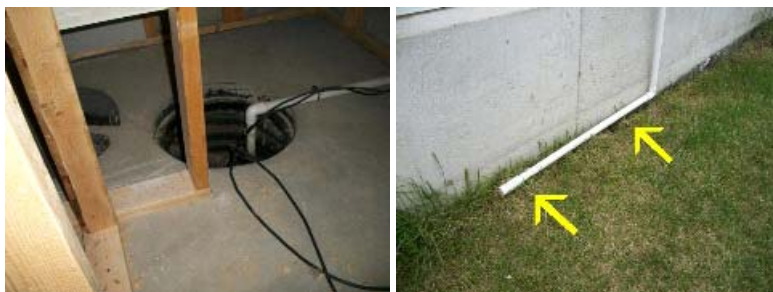
The sump pump system appeared serviceable, except: The exterior discharge line was poorly routed or terminates very close to the home's foundation. The pump's discharge line should be routed to the exterior of the structure and constructed in such a way that it maintains proper positive flow away from the foundation yet does not adversely affect exterior water drainage or neighboring properties.

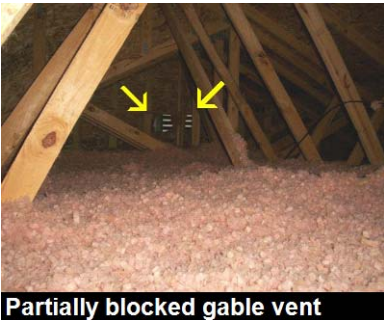
**Partially blocked gable vent****12.11 INSULATION TYPE AND CONDITION:**
