# MOORE

HOME • INSPECTION • SERVICES

RE: 1234 Really Nice Court Inspection Report

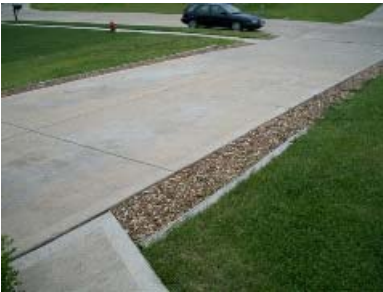
#### 3.2 CONDITION:

Appeared serviceable.

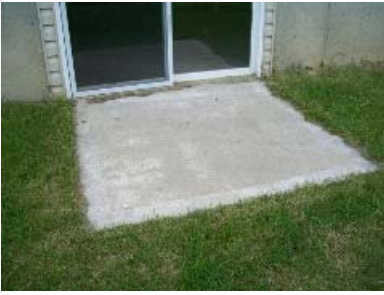
#### 3.5 CONDITION:

Appeared serviceable.

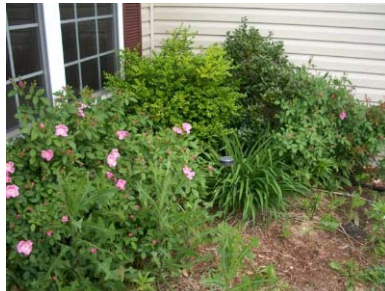
Lawns

Trim back at front

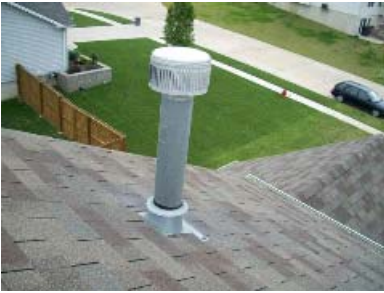
#### 5.5 CONDITION:

Appeared serviceable.

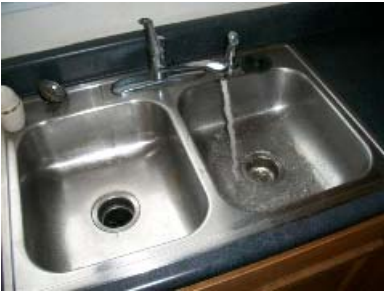
### 6.1 SINK - FAUCET - PLUMBING:

Sink appeared to be stainless steel. The sink basin, faucet/sprayer and plumbing lines appeared serviceable.

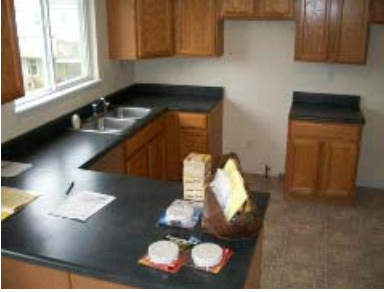
**6.2 COUNTERTOPS & CABINETS:**

Counters appeared to be predominantly made of a laminate material. Counter tops and cabinetry appeared serviceable.

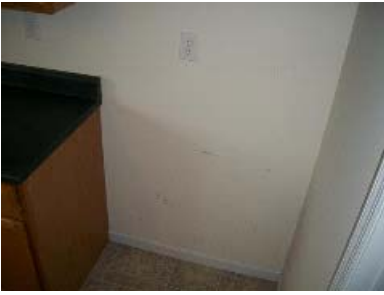
**6.5 REFRIGERATOR:**

No refrigerator present. Electrical outlet appeared serviceable and grounded.

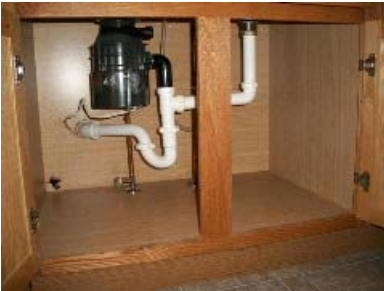
**6.7 GARBAGE DISPOSAL:**

Unit appeared serviceable. All electrical and plumbing hookups appeared serviceable, so far as visible.

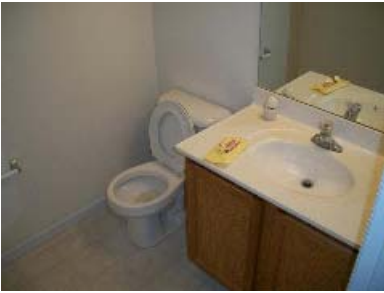
**7.1 BATH LOCATION:**

Main floor foyer.

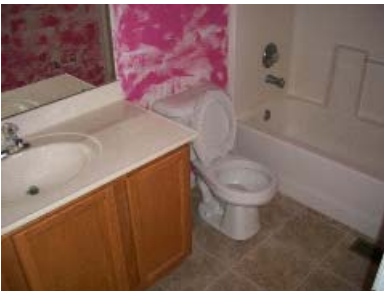
**7.5 BATH LOCATION:**

Second floor hallway.

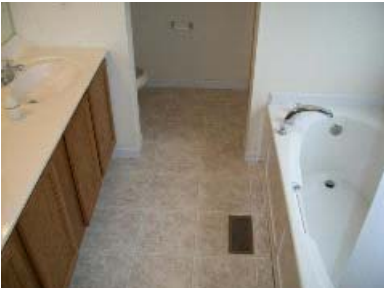
**7.10 BATH LOCATION:**

Second floor in master bedroom.

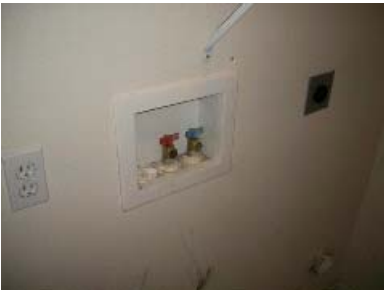
**8.11 PLUMBING CONDITION:**

All laundry area plumbing appeared serviceable. The faucets/valves were not tested.

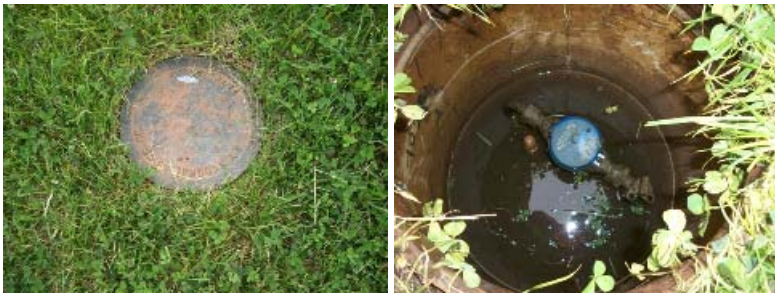
**9.3 EXTERIOR CONDITION:**

The main exterior stop box and meter appeared serviceable.

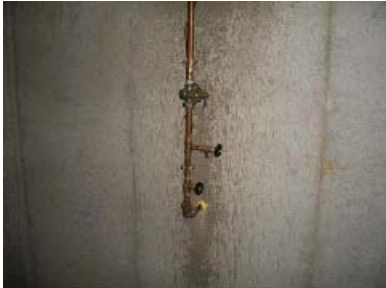
**9.4 INTERIOR CONDITION:**

The main interior line, valve and pressure regulator appeared serviceable. Valve and regulator were noted but not tested. Main line is 3/4 inch diameter. NOTE: See ELECTRIC PANELS for details on the electric panel's ground wire continuity.

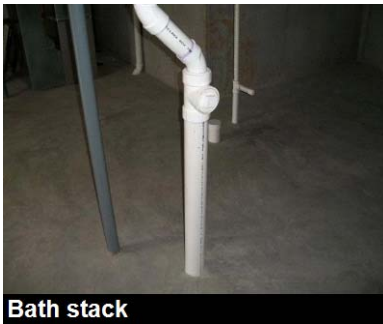
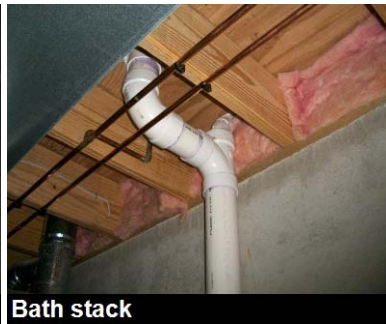
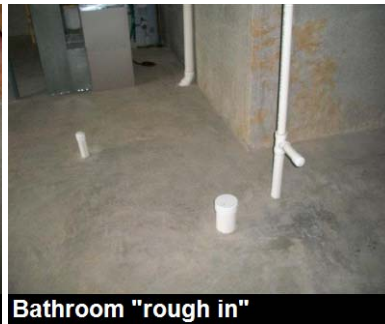
**9.8 CONDITION:**

Waste lines appeared serviceable. A fourth bathroom "rough in" was noted in the basement. NOTE: The waste lines and stacks were not completely viewable at the time of the inspection. A limited inspection was performed.

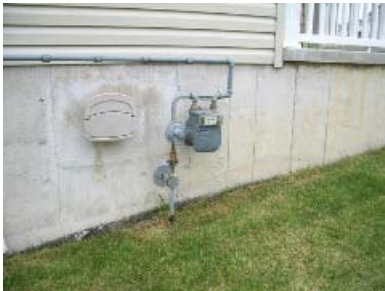
### 10.2 LOCATION OF GAS METER(S):

The gas meter is located outside at the north wall.

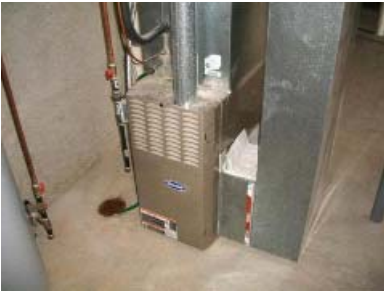
### 10.6 MAIN CABINET & INTERIOR:

Appeared serviceable.

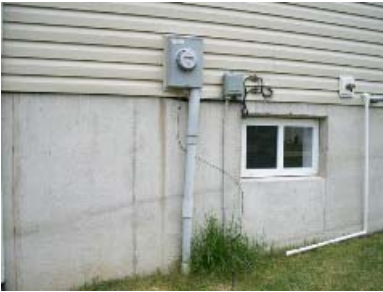
### 11.1 TYPE AND CONDITION:

Main electric service is 110/220 volt, underground service supplying a 100 amp main panel utilizing circuit breakers. Main service appeared serviceable.

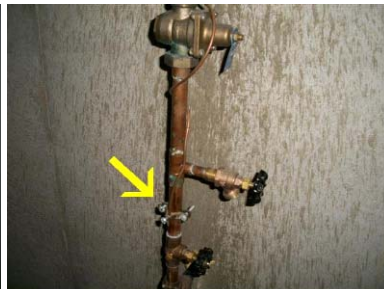
Circuit and wire sizing correct so far as visible. The panel appeared serviceable, except: 1) Although an exterior driven ground was viewed, the primary interior cold water grounding system appeared to be deficient. The cold water ground wire was present and properly attached to some interior copper water pipes (near the main interior valve). However, the plumbing main line at the front foundation wall was non-metallic (plastic) which will not permit electrical ground continuity beyond the plastic/copper connection. In this situation, replacing the plastic main water line with a conductive metal may be cost prohibitive. As such, we recommend checking with the local jurisdiction having authority to determine if the single exterior driven ground is sufficient to meet local codes or occupancy requirements. 2) Some of the branch wire openings were missing appropriate strain relief connectors or clamps. This was seen at the top of the main panel. We recommend further evaluation and necessary repairs by a qualified professional familiar with such conditions.

Nullified interior ground

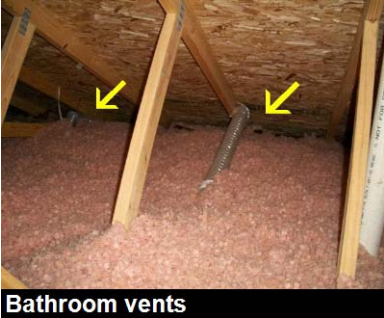
Attics are full size. Multiple attic spaces were viewed (house and garage). Truss framing noted. Attics were accessible. Viewing was limited to observing from hatch areas only. Attic spaces appeared serviceable, except: One or more bathroom vents appeared to be terminating in attic space, not outside of structure. This may contribute to excess moisture in the attic. In extreme cases, excessive moisture in the attic can cause damage to the framing material, roof shingles and can cause the insulation to lose its effectiveness. Ideally, such vents should terminate to the exterior of the residence.

**Bathroom vents****12.10 VENTILATION TYPES AND CONDITION:**
